# **Characterization of High Temp Thermal Sprays for Engine Applications**

Nick Jacobs – UDRI

Presented at HCAT – Kennedy Space Center

November 19, 2003

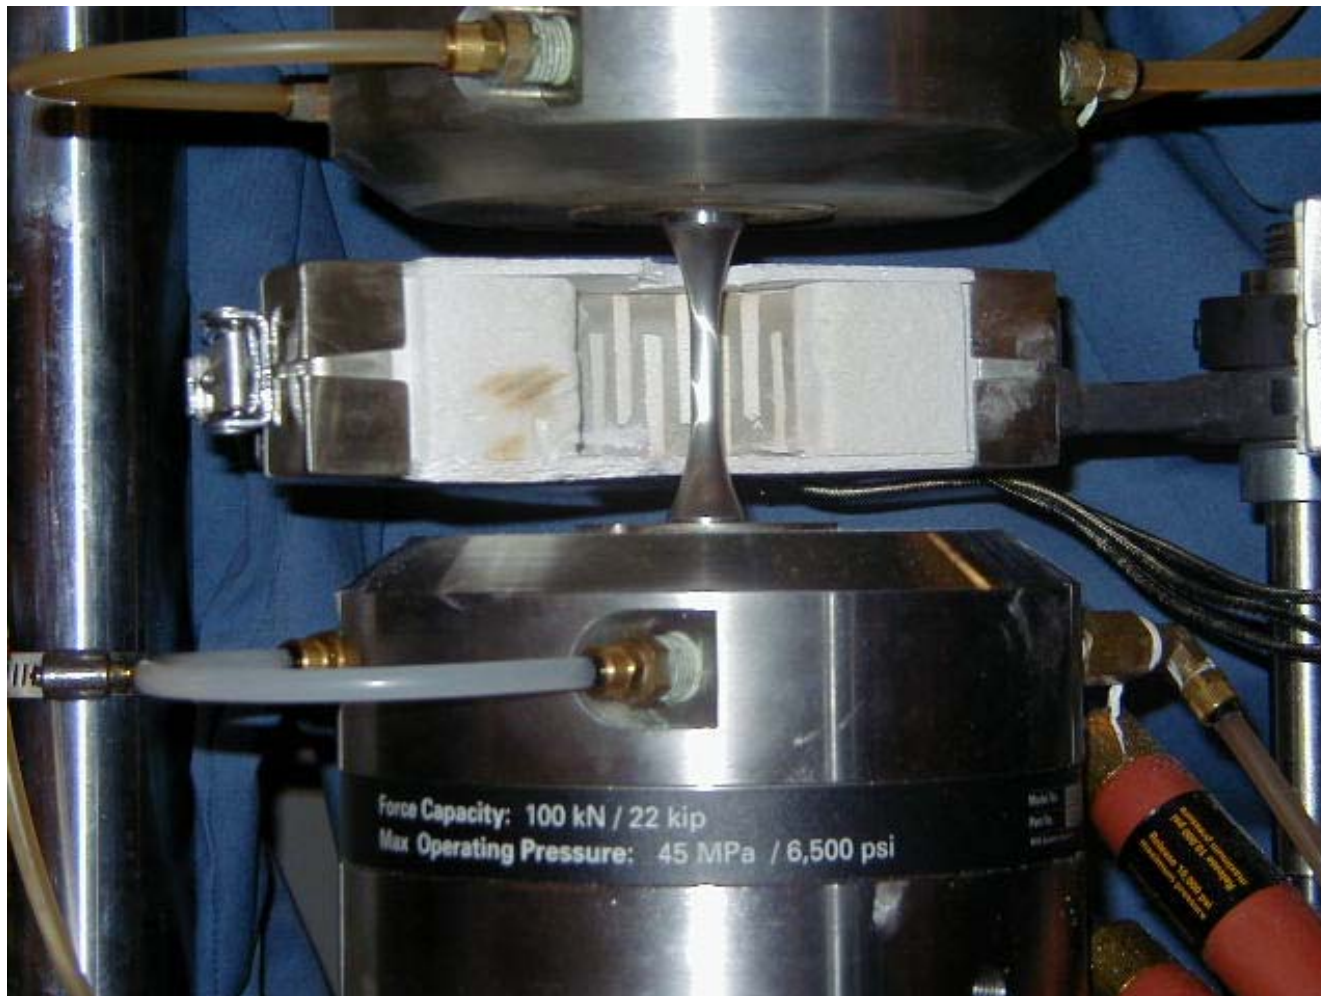
# Fatigue Setup

- Directly compare EHC to HVOF and PS coatings
- Specimen Details
  - *Sprayed Shoulder to Shoulder*
  - *Uniform 1/4" Gage Diameter, 3/4" Gage Length*
  - *Stress Ratio=0.1, Frequency = 30 Hz*
- Full Matrix vs. EHC baseline
  - *Two Substrates (17-22 Steel; Inconel 901)*
  - *Two Temperatures (300 °F, 750 °F)*
  - *One Thickness (0.010 inches)*
  - *Four Coatings*
    - *HVOF: WC-Co17; Tribaloy-400; Ni,Cr*
    - *PS: WC-Co17*

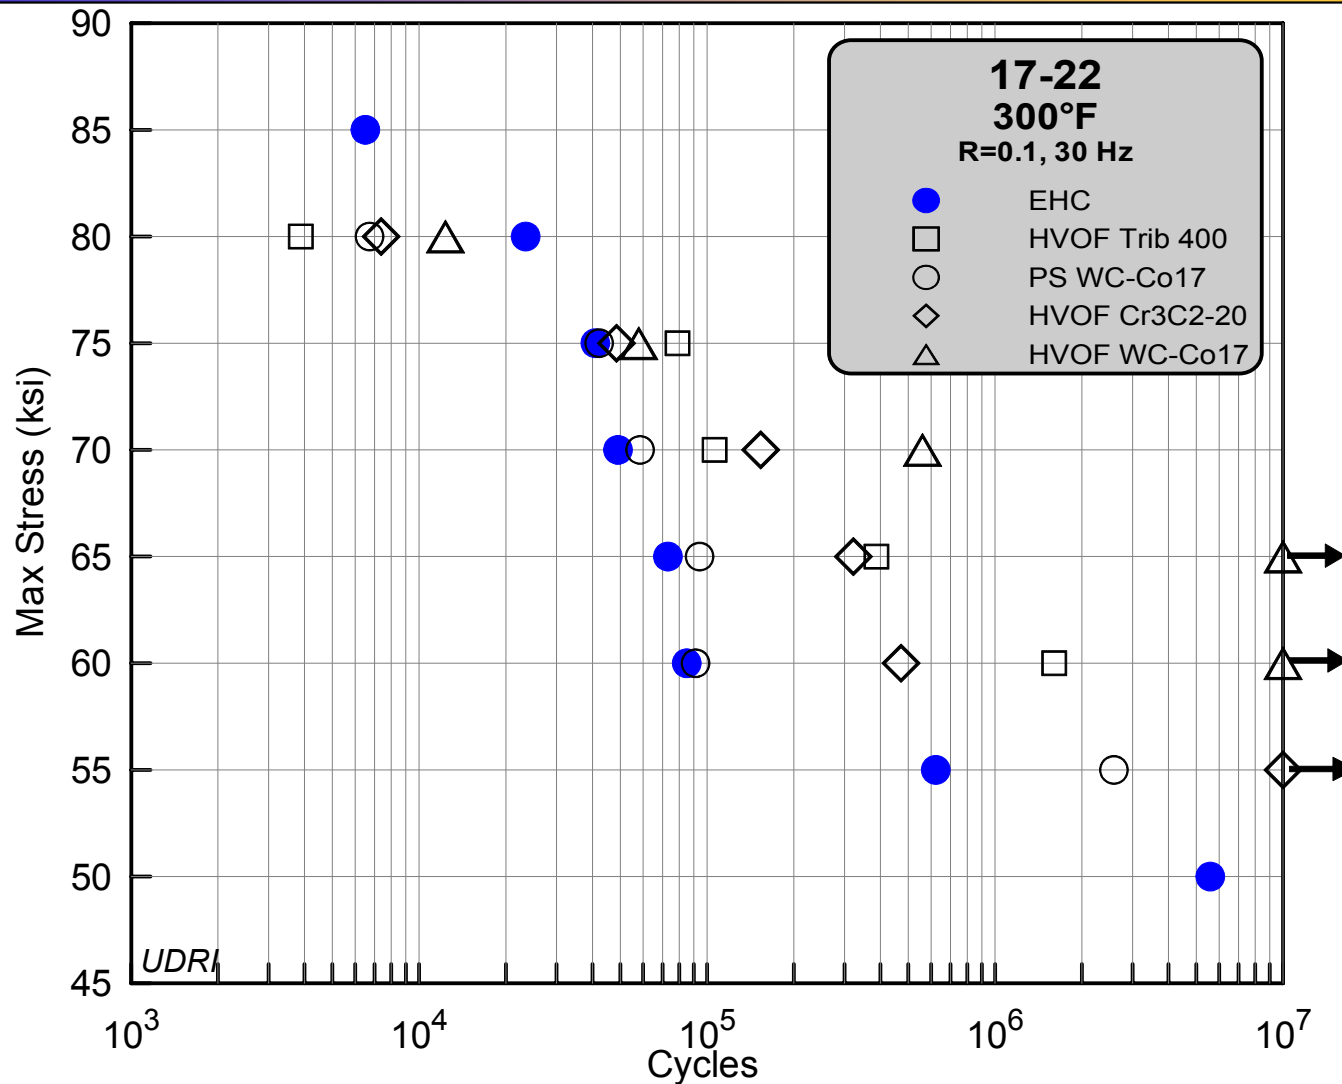
# Fatigue Results

## 17-22 Steel @ 300°F

- HVOF performed better than or equal to EHC
  - *Difference in Fatigue properties is not statistically significant*
  - *Test used as a performance discriminator, not intended for fatigue critical applications*
- No significant fatigue debit associated with thermal spray coatings as compared with EHC
- In general, HVOF performed better than PS

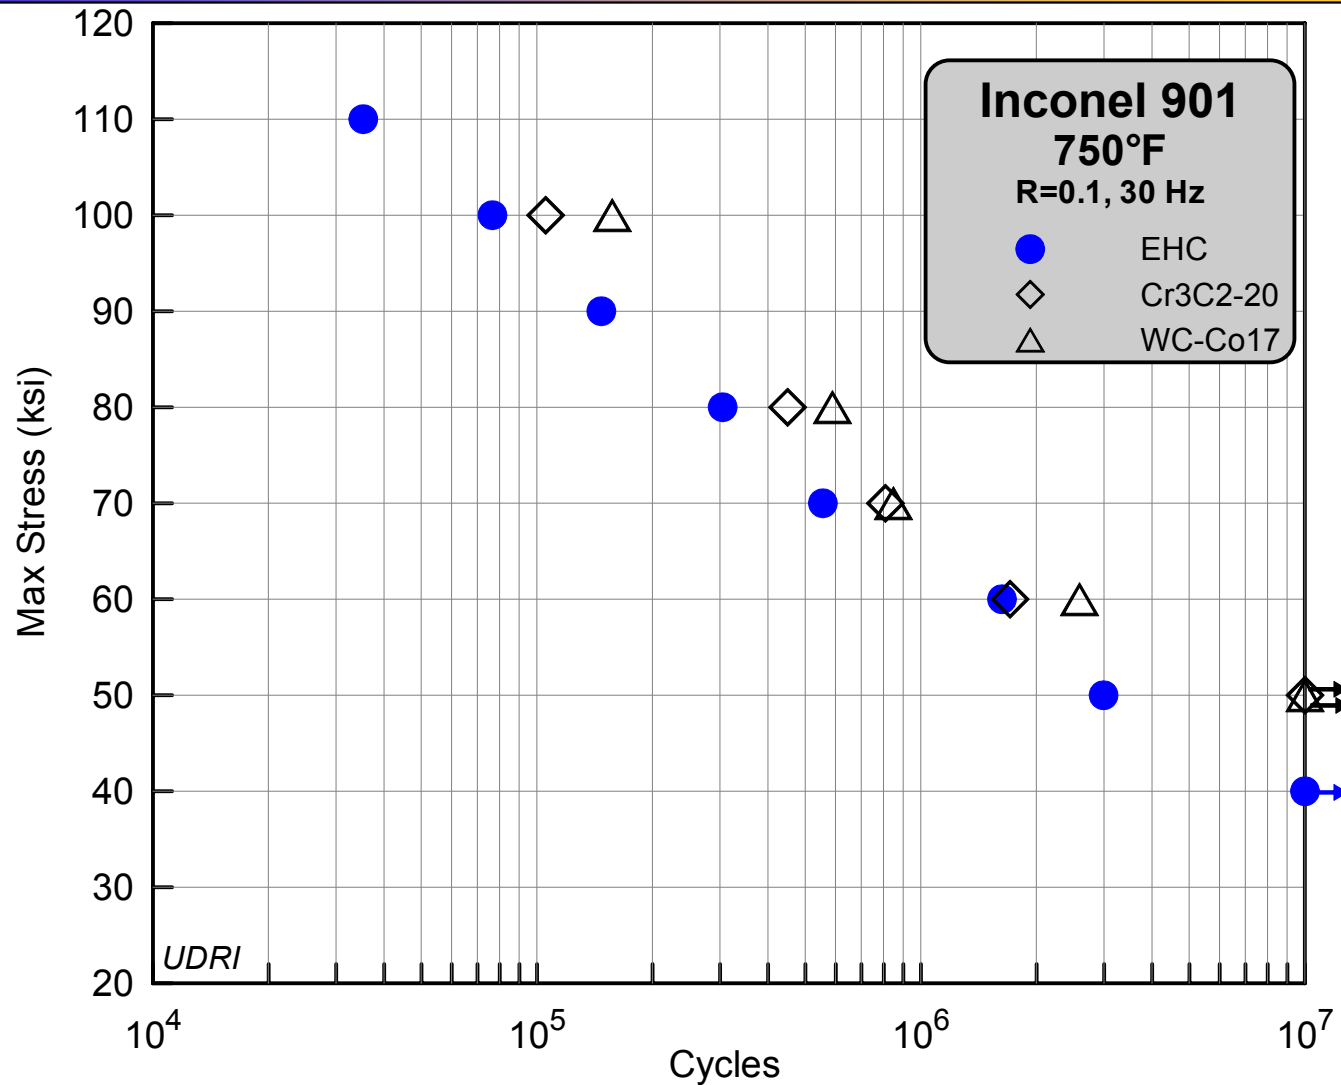
# Fatigue Results

## Inconel 901 @ 750°F

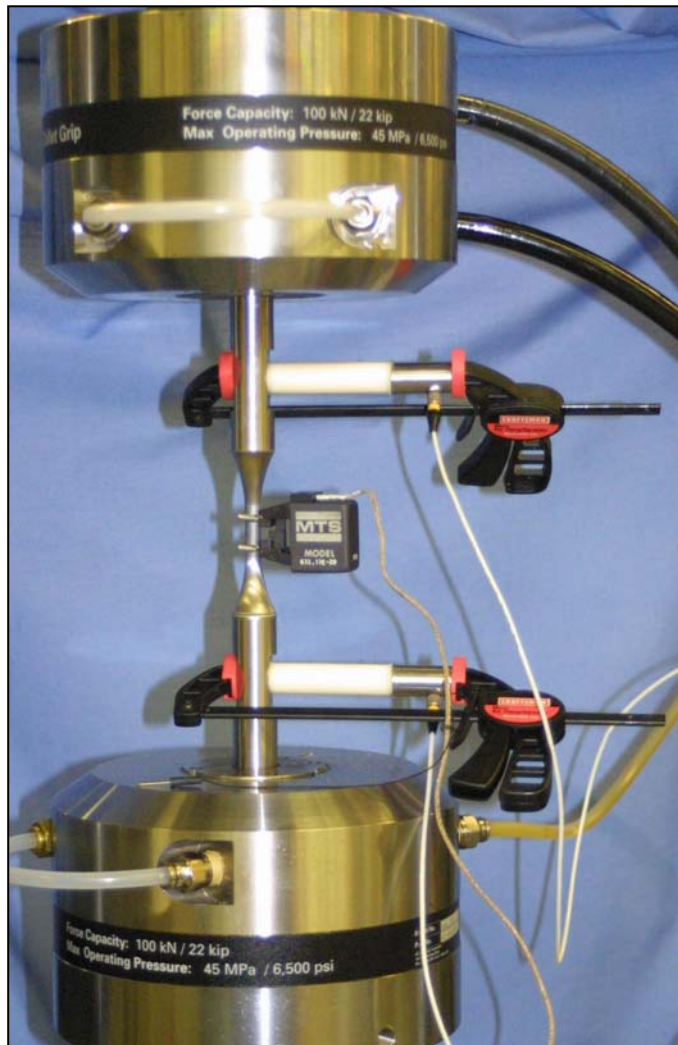
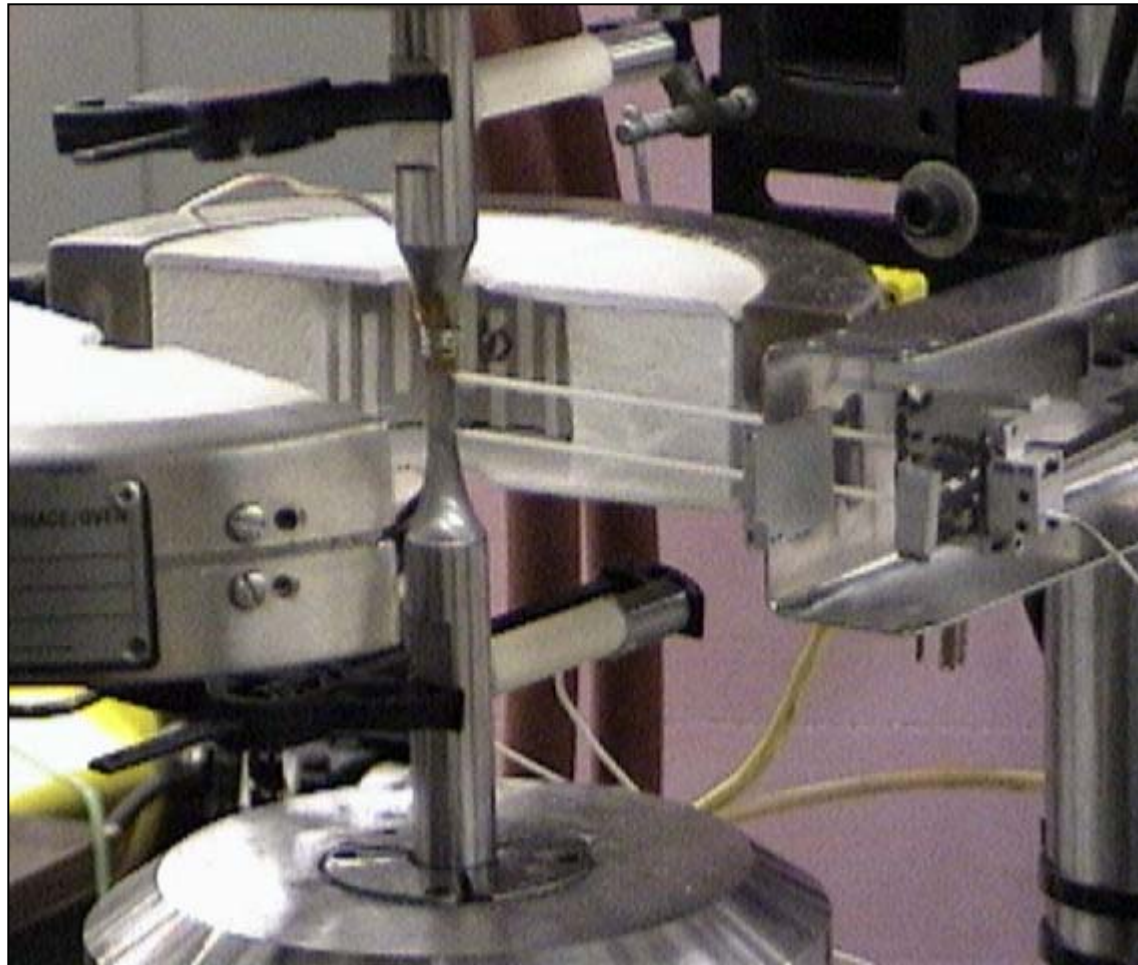
# Acoustic Emission Setup

- Strain to Fracture with Acoustic Emission Detection
  - *Detect cracking of coating prior to substrate tensile failure*
    - *Record AE energy, duration, location, load, strain, timestamp*
    - *Record high level signals (Load, Strain) as in typical tensile test*
  - *Goal: Detect minimum strain required to cause cracking in coating*
- Elongated Tensile Specimen modified for AE Sensors
  - *Two Substrates (17-22 Steel; Inconel 901)*
  - *Three Temperatures (R.T., 300 °F, 750 °F)*
  - *Two Thicknesses (0.003 inches, 0.010 inches)*
  - *Five Coatings*
    - *HVOF: WC-Co17; Tribaloy-400; Ni,Cr*
    - *PS: WC-Co17; Tribaloy-400*

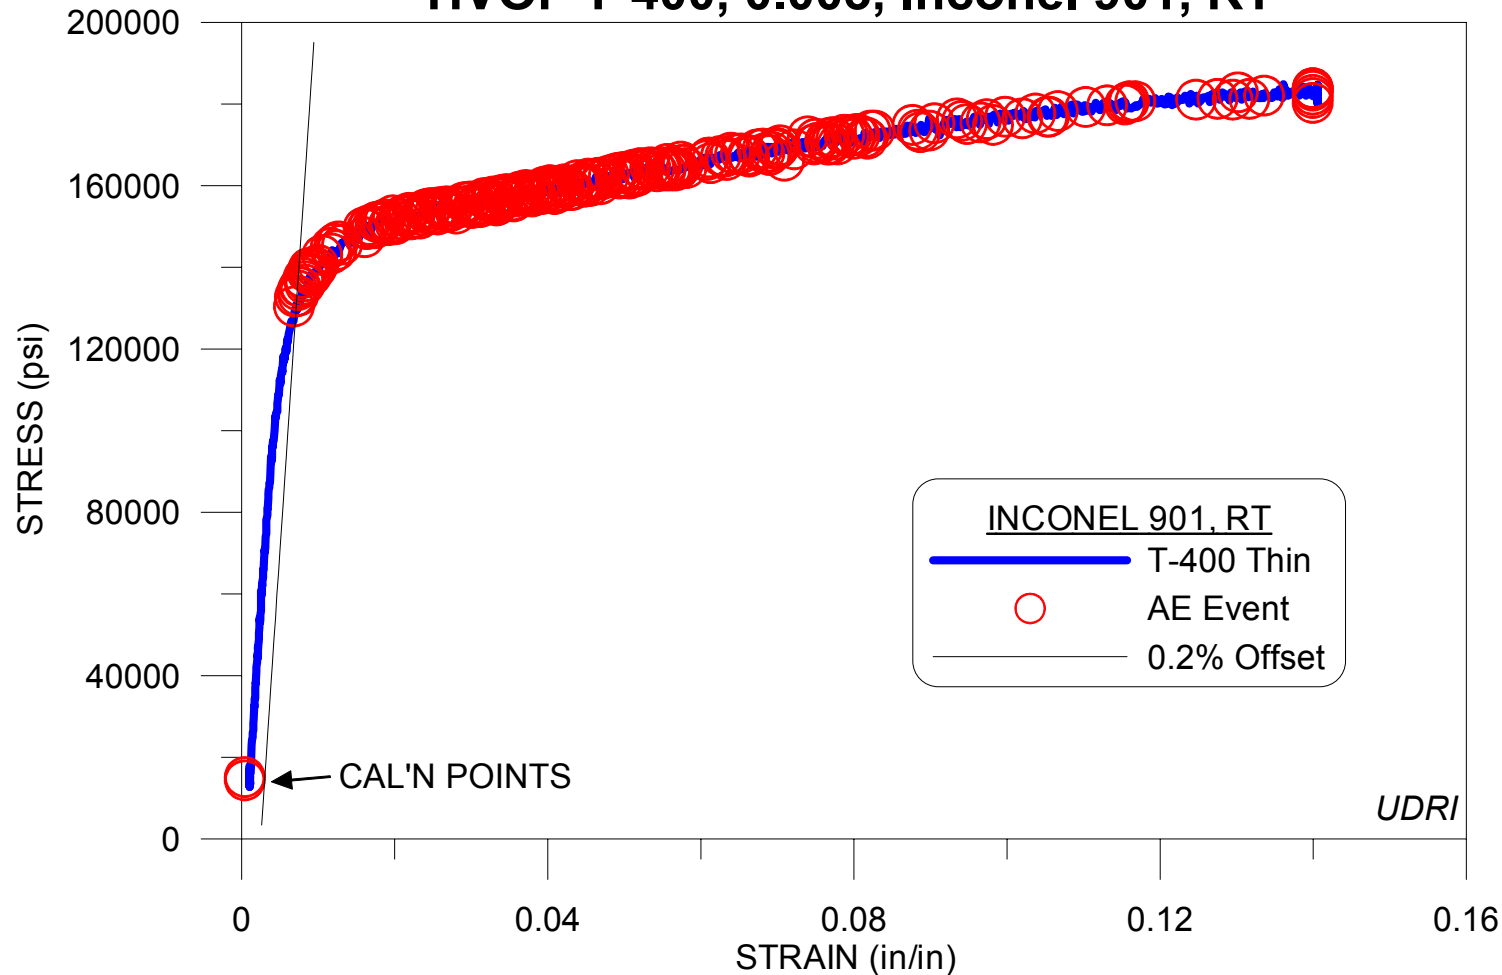
# Acoustic Emission Results

**Typical Stress-Strain Curve with AE Events**  
**HVOF T-400, 0.003, Inconel 901, RT**

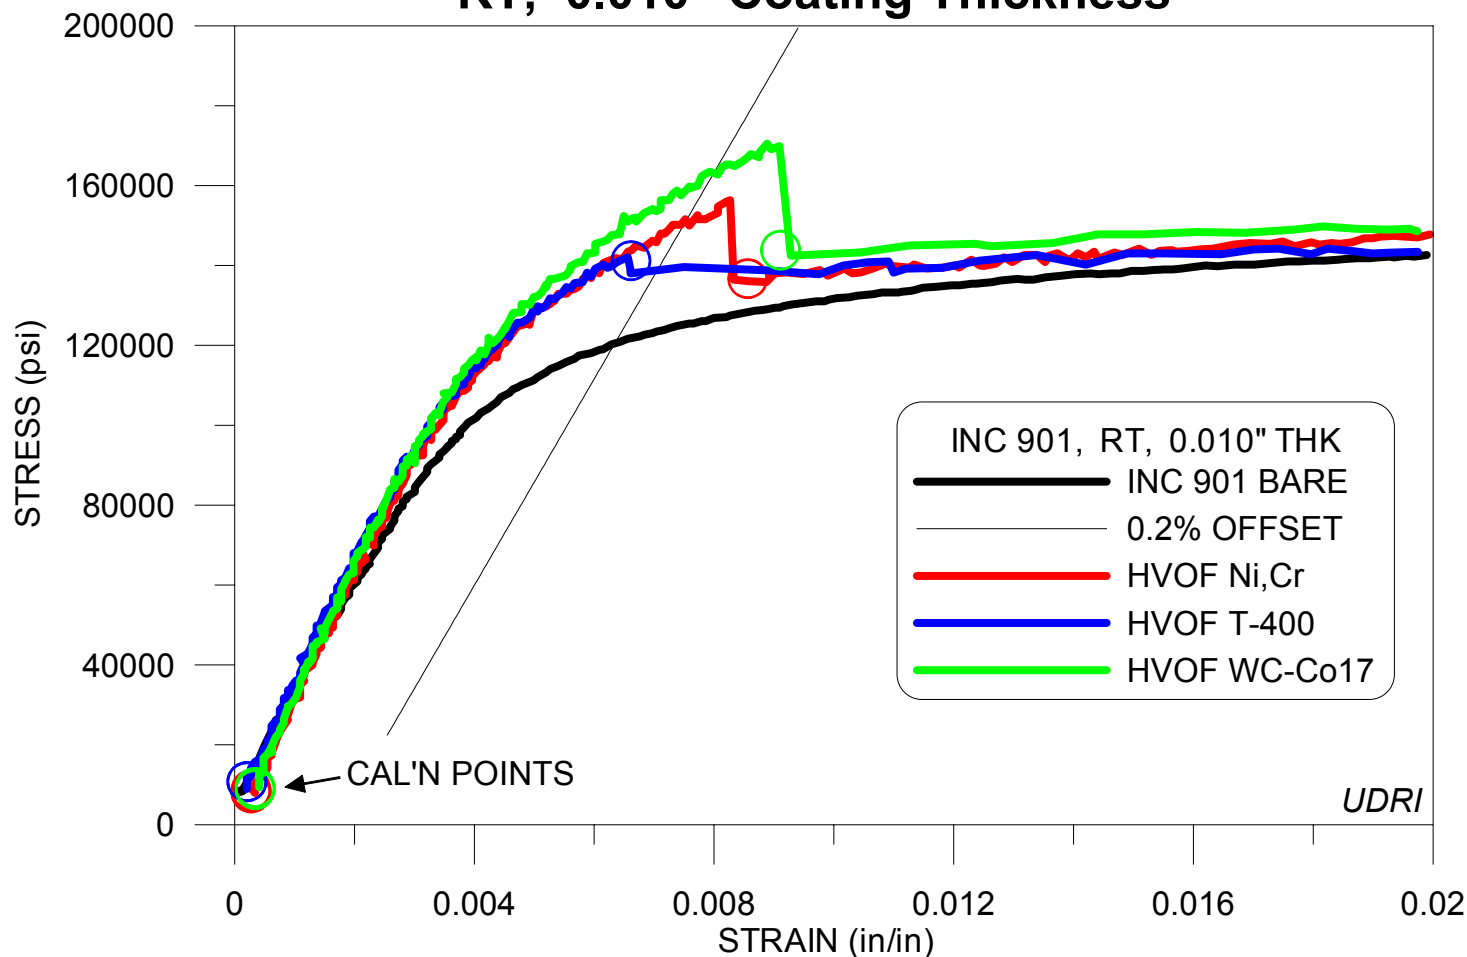
# Acoustic Emission Results

## Initial AE Event with Load Drop, Inconel 901 RT, 0.010" Coating Thickness

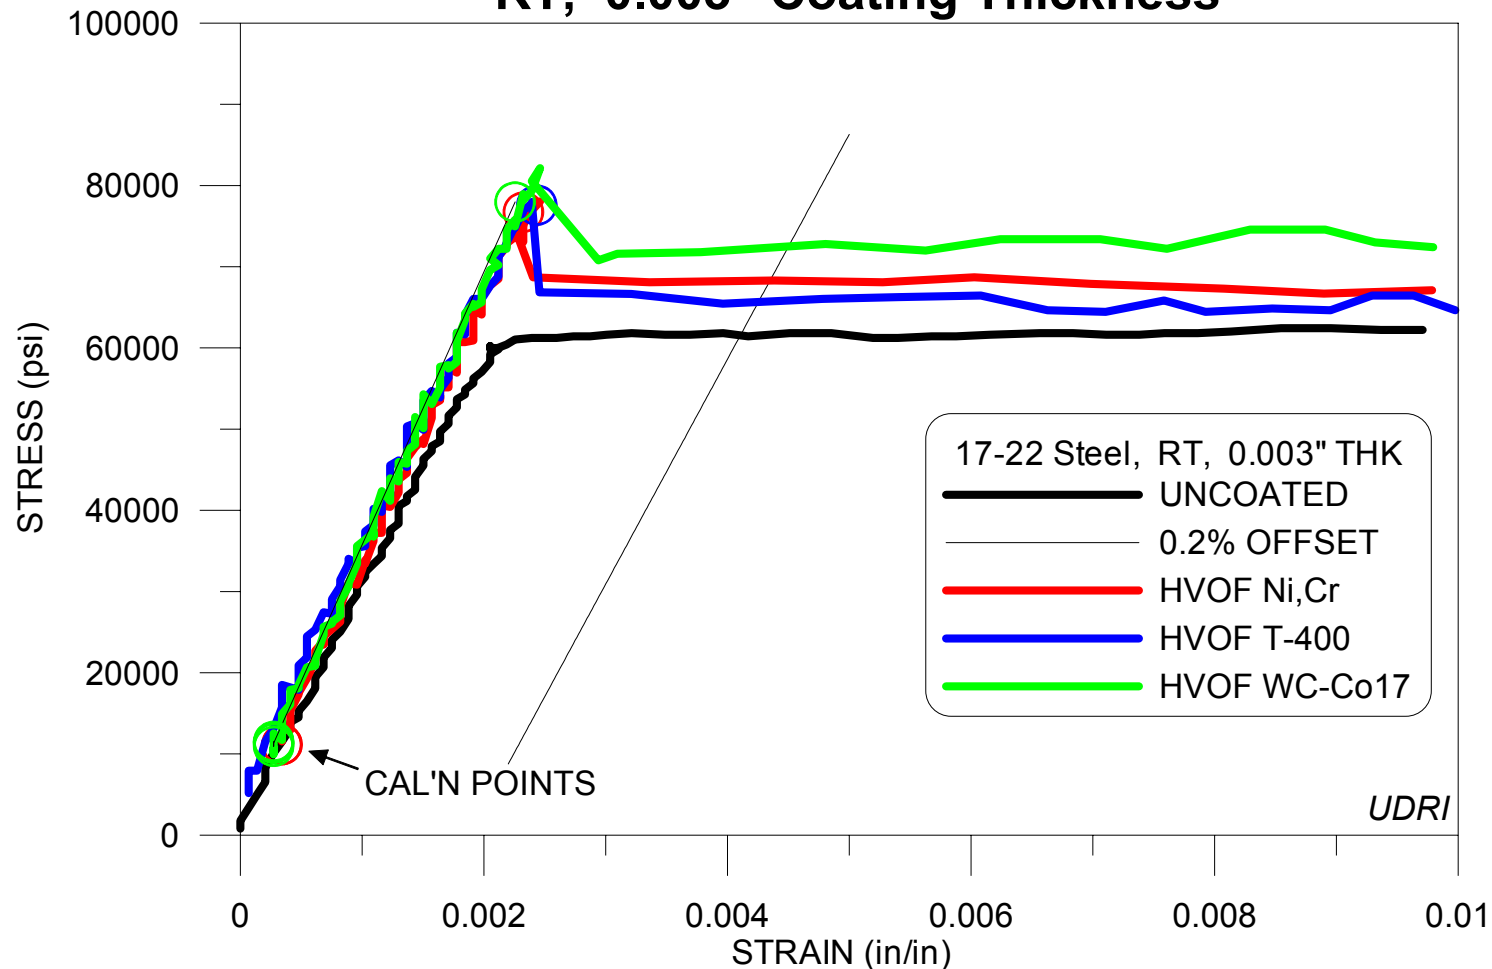
# Acoustic Emission Results

## Initial AE Event with Load Drop, 17-22 steel, RT, 0.003" Coating Thickness

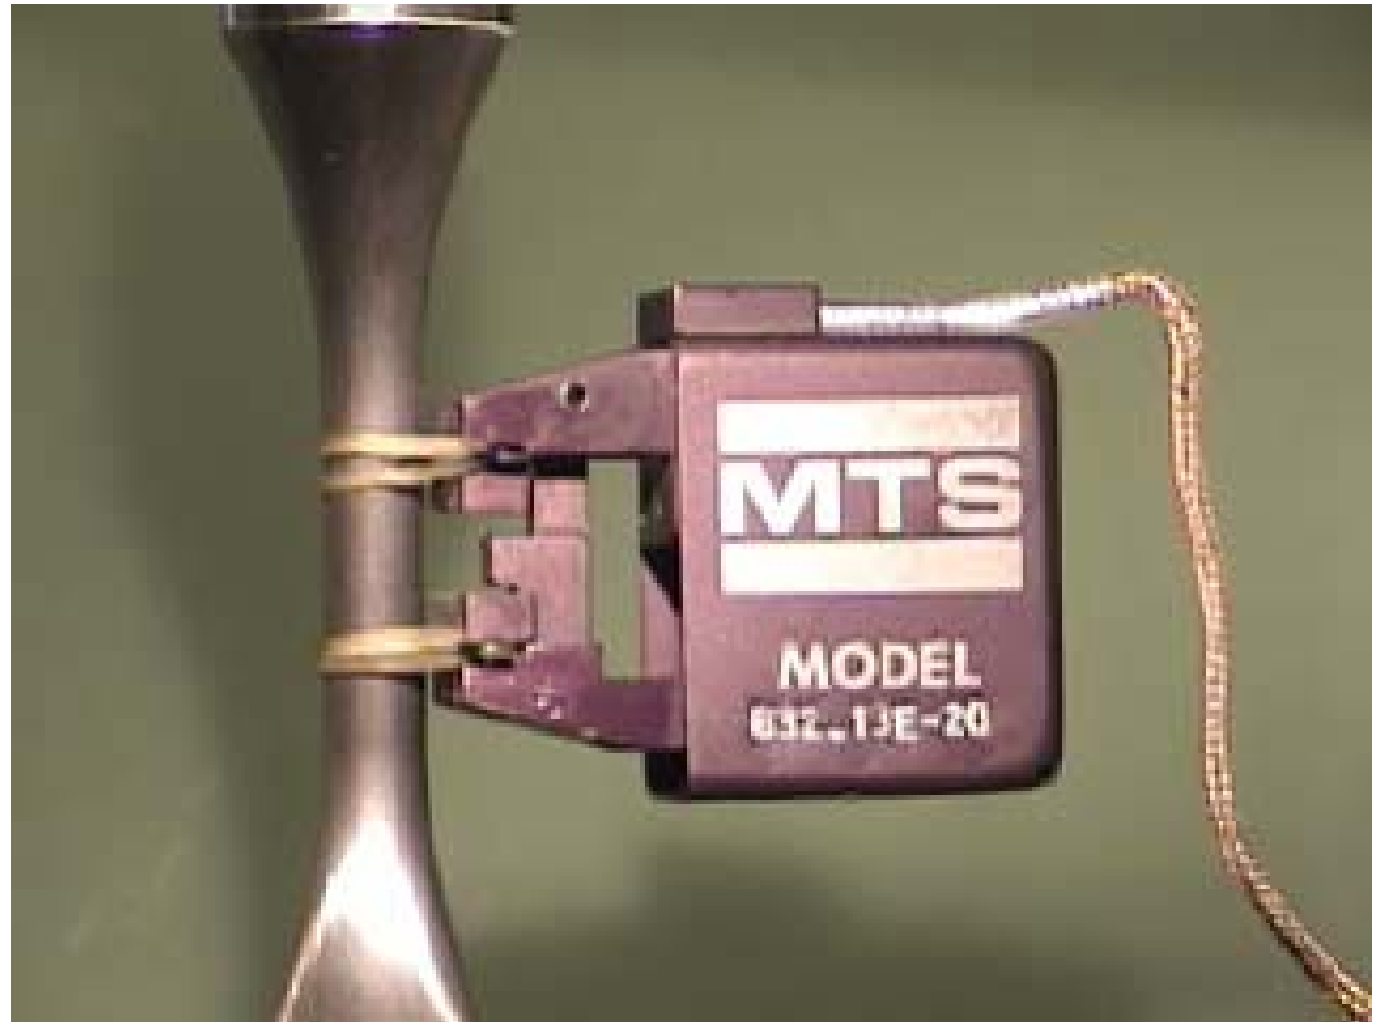
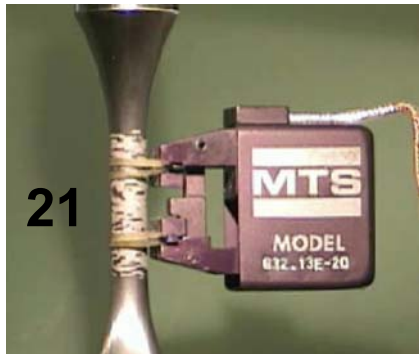
# AE – Failure Modes

## *Thin Coatings*

Typical Fail Mode:

Spalling/Flaking –

Patch Delamination

(HVOF Ni Cr, 0.003")

HVOF WC-Co 0.003"

PS WC-Co17 0.003"

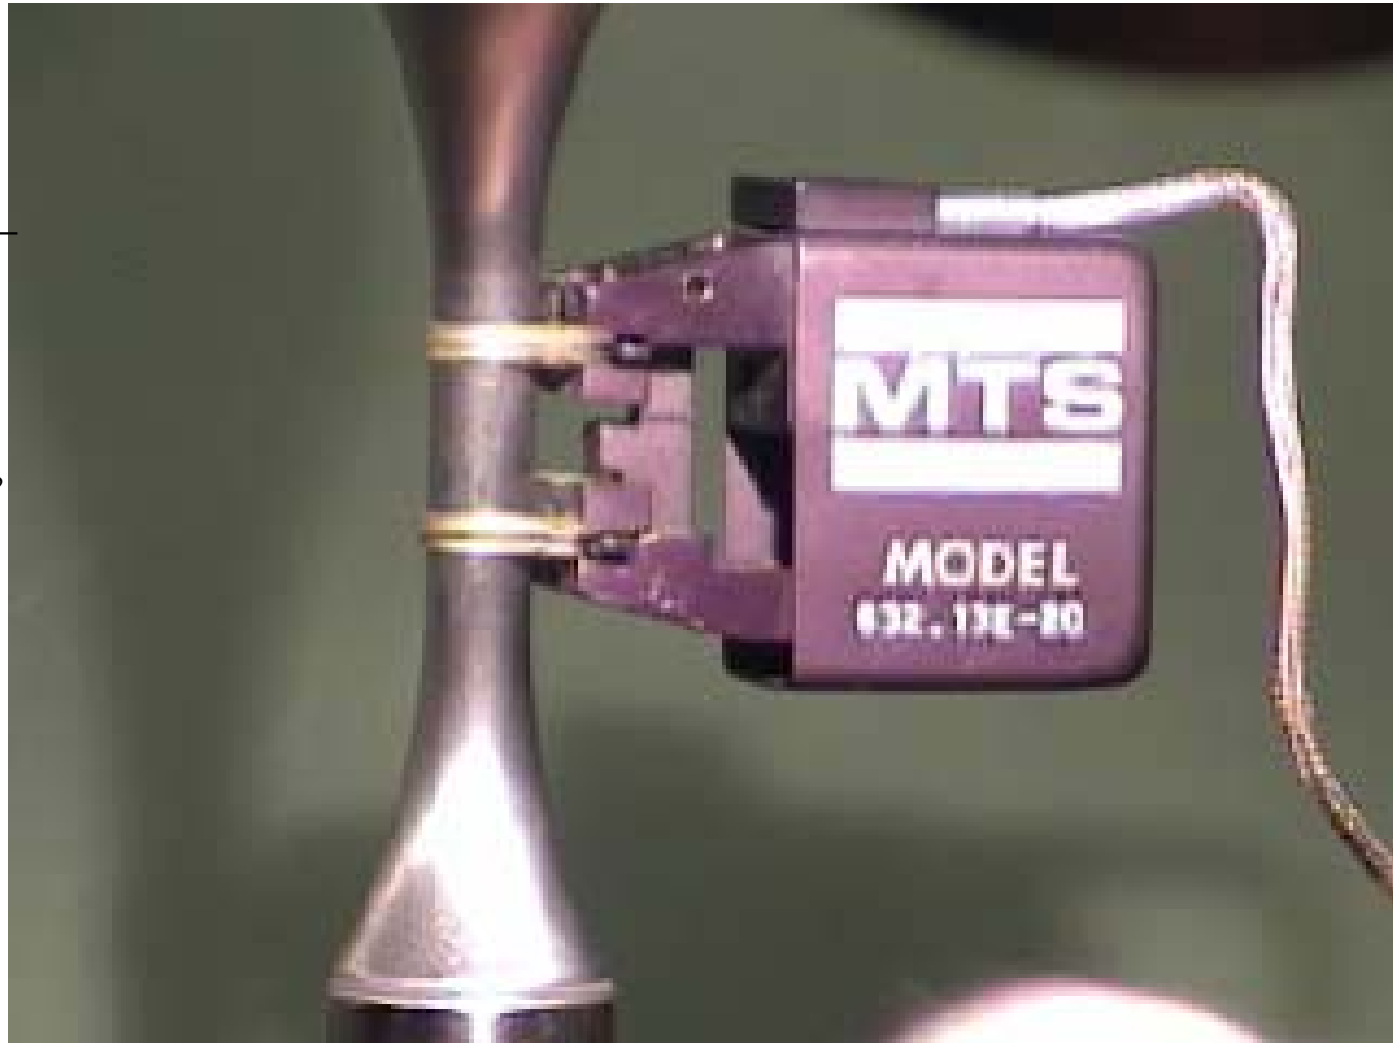
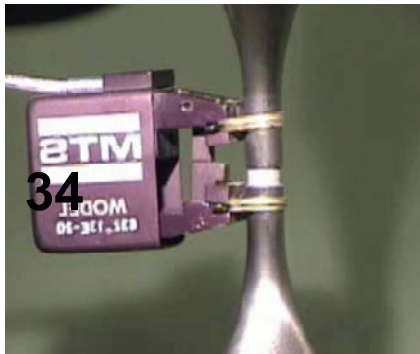
# AE – Failure Modes

## *Thick Tribaloy-400*

Typical Fail Mode:  
Cigar Band Delam –  
Circumferential Cracks –  
Lateral Contraction  
(HVOF T-400, 0.010")  
PS Tribaloy-400, 0.010"

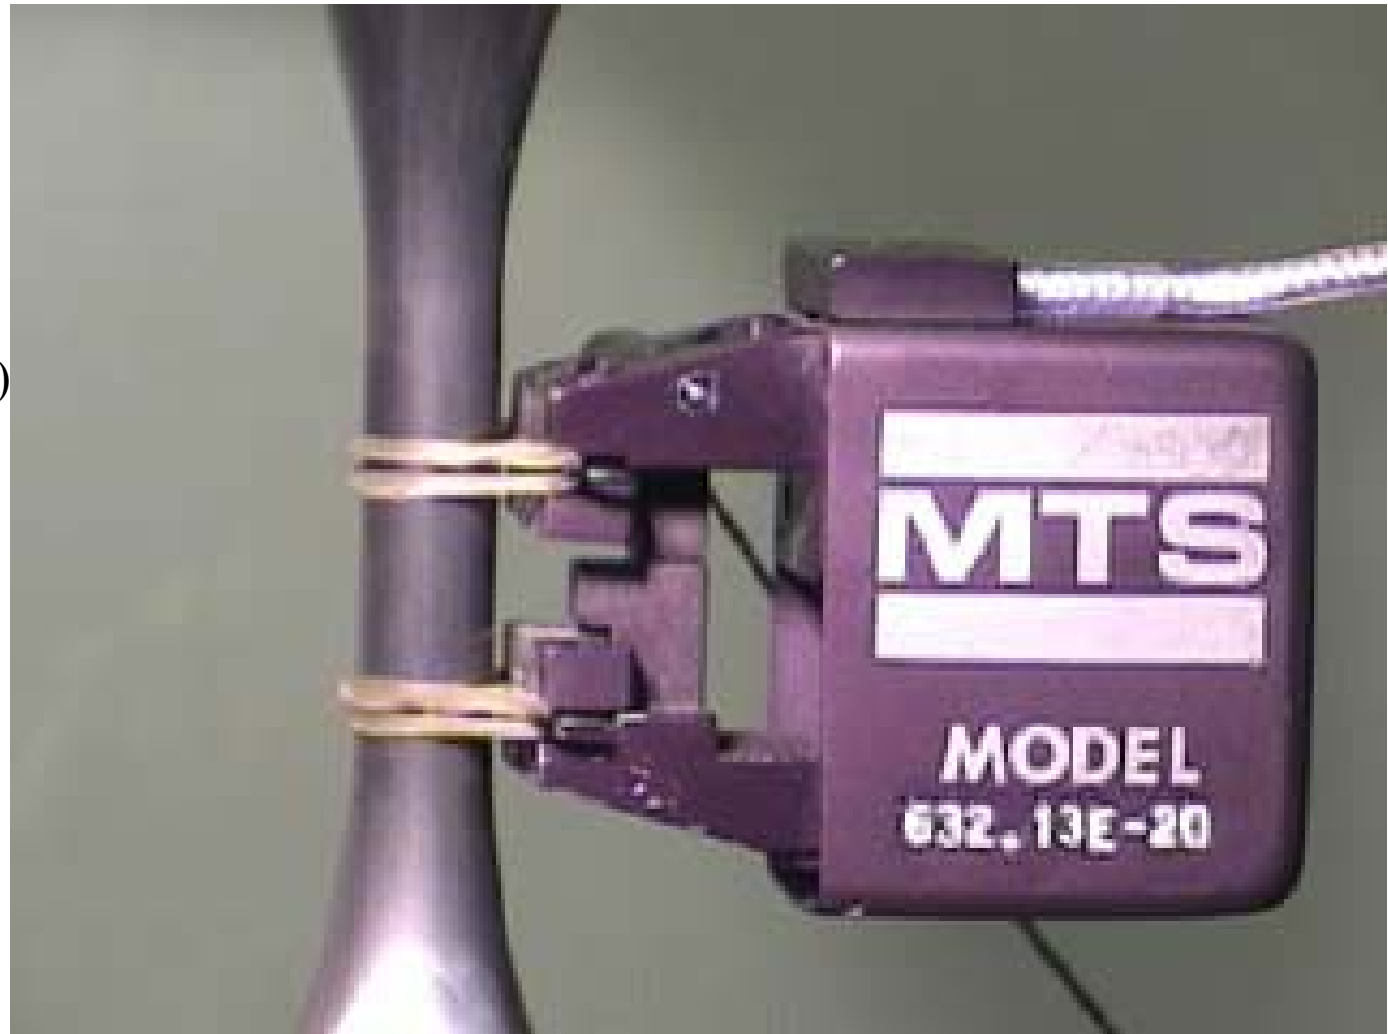
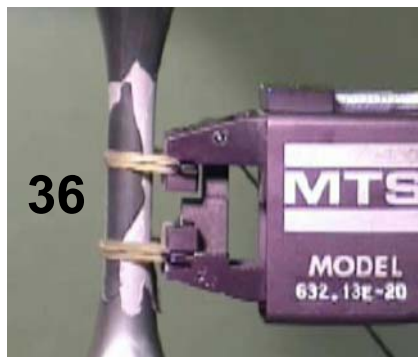
# AE – Failure Modes

## *Thick WC-Co and Ni,Cr*

Typical Fail Mode:  
Coating suddenly  
shatters – Coating  
carry load?

(HVOF WC-Co, 0.010")

HVOF Ni Cr, 0.010"

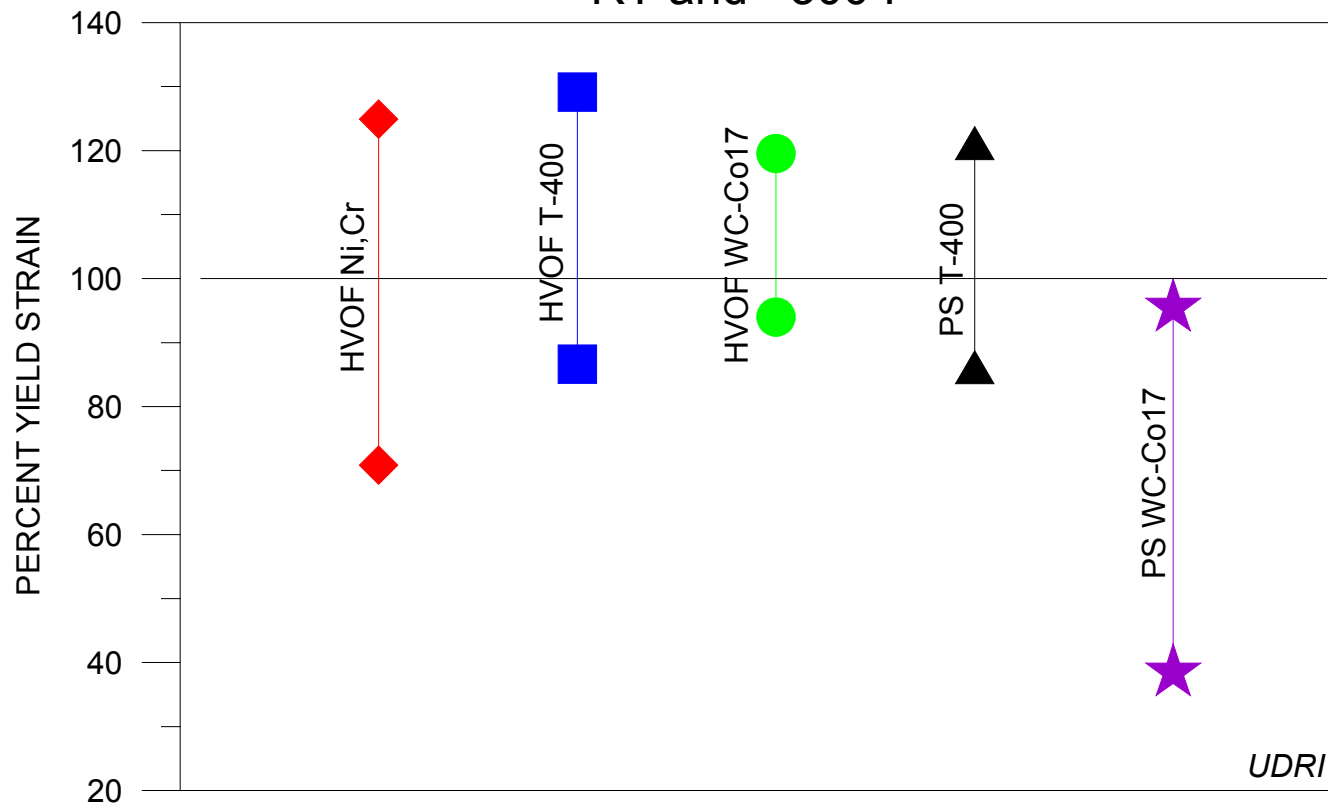
# AE Failure Strain

## *Initial Cracking of Coating*

Coating Failure Strain Ranges, 17-22 Steel  
RT and +300 F

- PS coatings began to crack at far lower stress and strain levels
  - Tribaloy-400 minimum strain 0.17% (32% YS – 750F)
  - WC-Co17 minimum strain 0.05% (5% YS – 750F)
- HVOF coatings began to crack near yield point in both substrates
  - Tribaloy-400 minimum strain 0.54% (85% YS – 750F)
  - WC-Co17 minimum strain 0.45% (90% YS – RT)
  - Ni,Cr minimum strain 0.32% (80% YS – 300F)
- Evidence of coating carrying load? In some coating conditions
  - Most evident in thicker HVOF WC-Co17 and HVOF Ni,Cr coatings, on 17-22 and Inc 901, at RT and elevated temp
- In general, the HVOF coatings began to fracture near the yield point of the substrate.
  - Further investigation necessary with higher strength substrates – follow on project

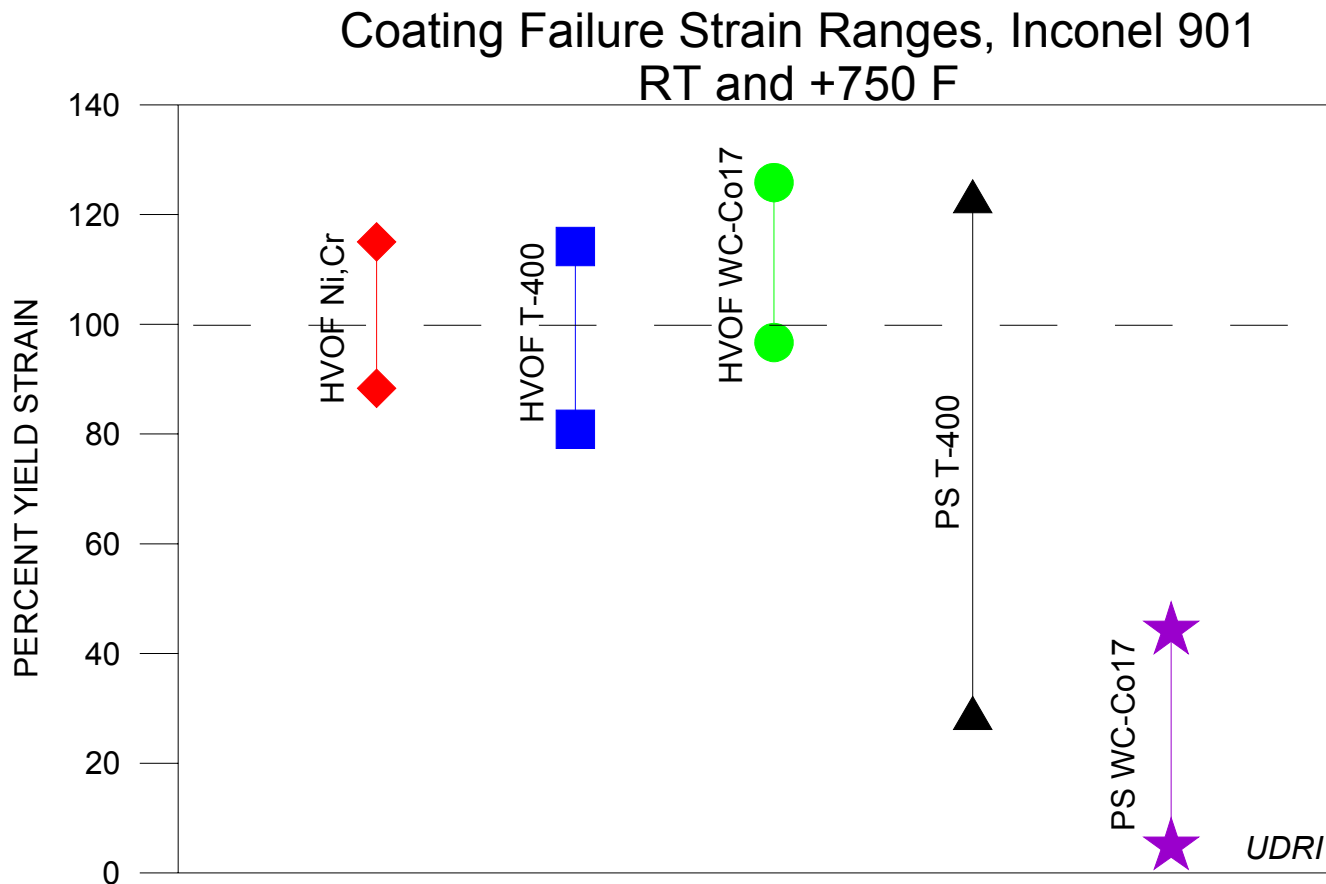
# AE Failure Strain

## *Initial Cracking of Coating*

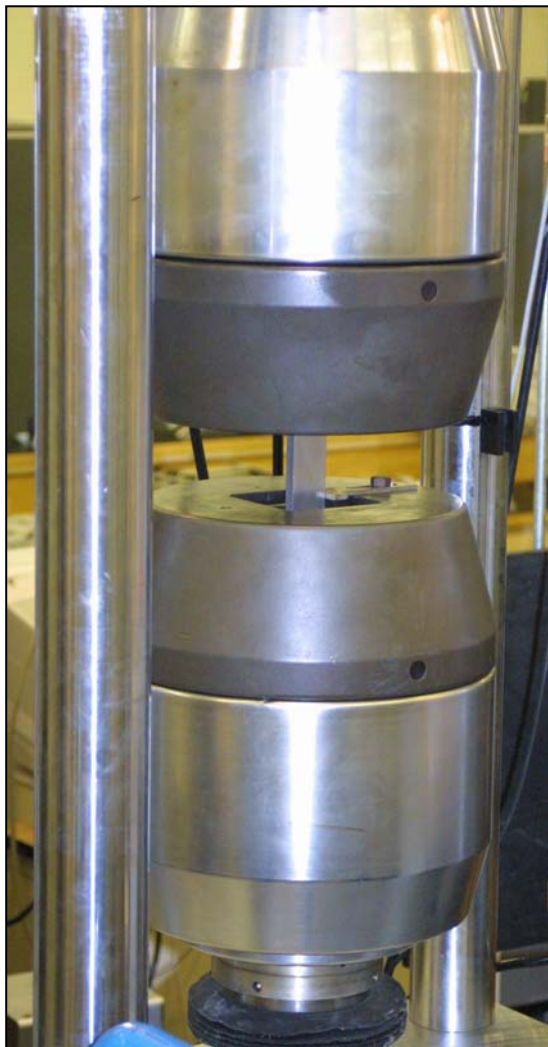
# Adhesion Setup

## *Damage Mechanisms*

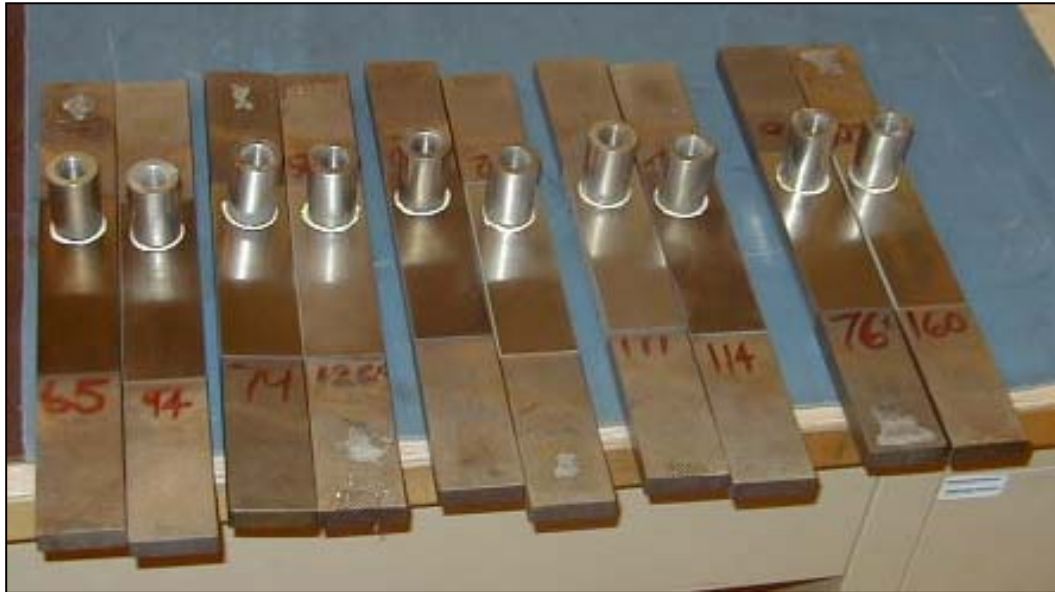
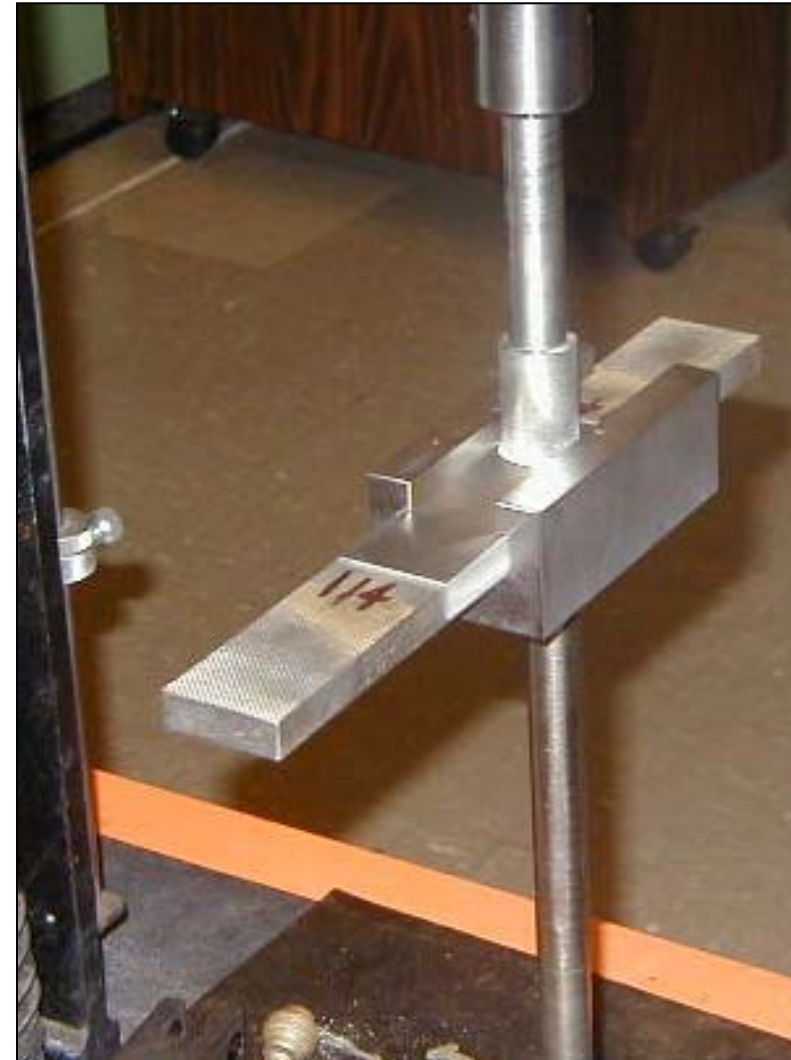
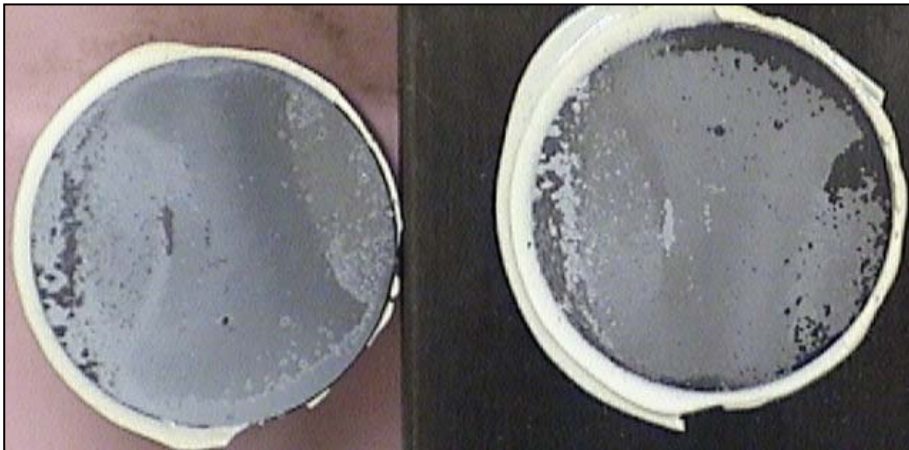
# Adhesion Setup

## *Bond Buttons*

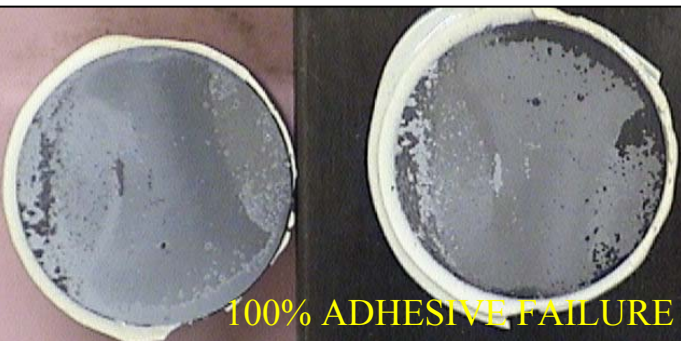
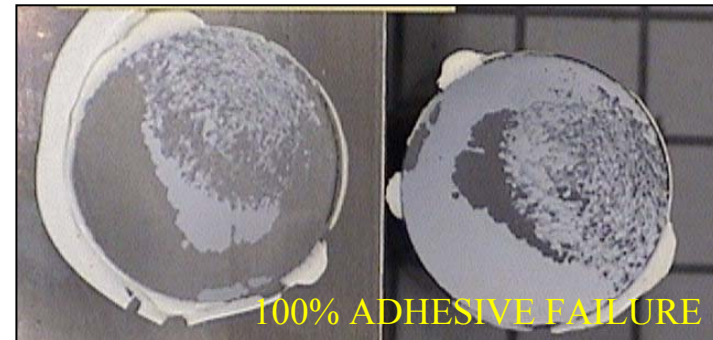
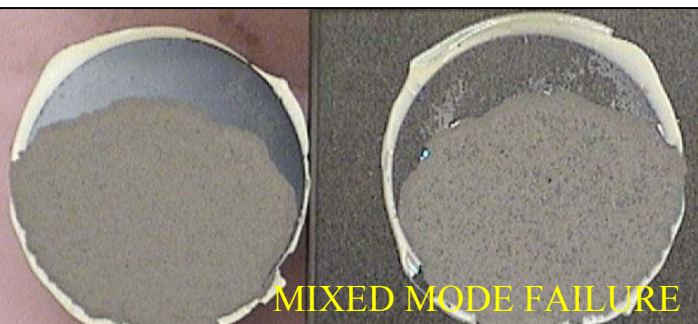
Adhesive failure, ~10 ksi  
failure stress

*HVOF WC-Co17, NiCr*

- Increasing Damage with constant life or stress
  - *HVOF*
    - *Ni,Cr - maintained 10ksi adhesive strength, >90% adhesive failures*
    - *WC-Co17- maintained 10ksi adhesive strength, >95% adhesive failures*
    - *T-400 - maintained ~10ksi adhesion strength, ~60% adhesive failures*
  - *PS*
    - *WC-Co17 – 10 ksi fell to 6-7 ksi after stress, 90% adhesive fail fell to <10% after stress*
    - *T-400 - constant poor adhesive strength ~4 ksi, constant 0% adhesive fail*

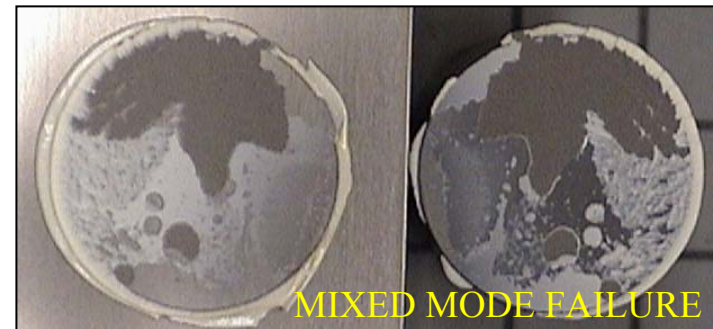
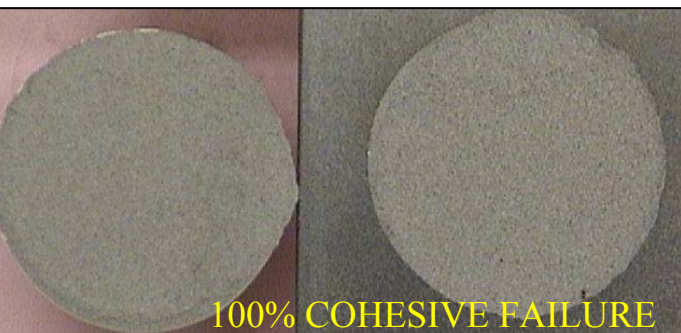
Mixed Mode failure, 4-10  
ksi failure stress

*HVOF T-400*

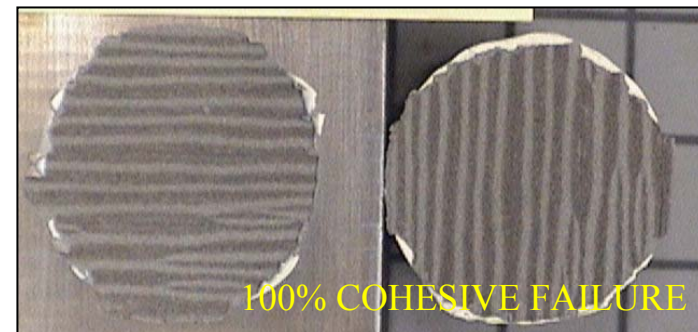
Cohesive failure, 3-5 ksi  
failure stress

*PS T-400, PS WC-Co*
